Westmoreland County Shoreline Management Plan

***Prepared for
Westmoreland County and
Virginia Coastal Zone
Management Program***

Virginia Institute of Marine Science
College of William & Mary
Gloucester Point, Virginia

February 2013

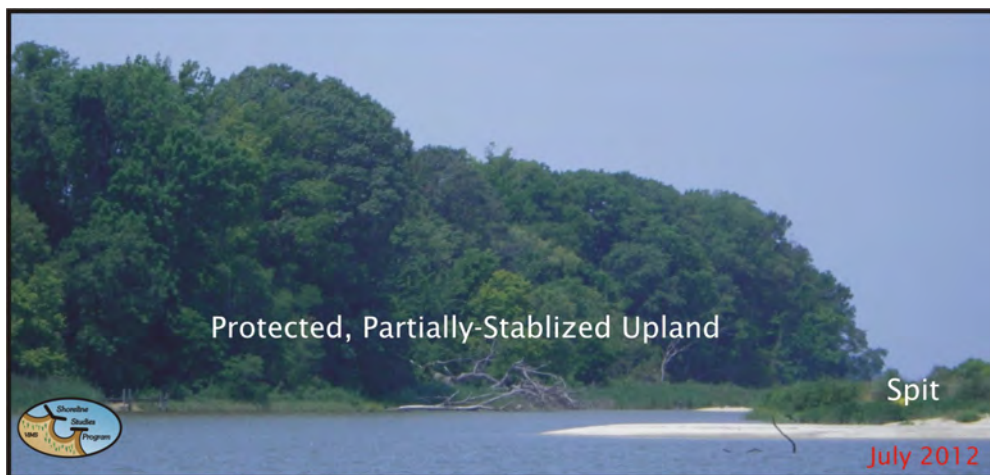
Figure 5-9. Photo of the spit and protected bank along Bettys Neck.

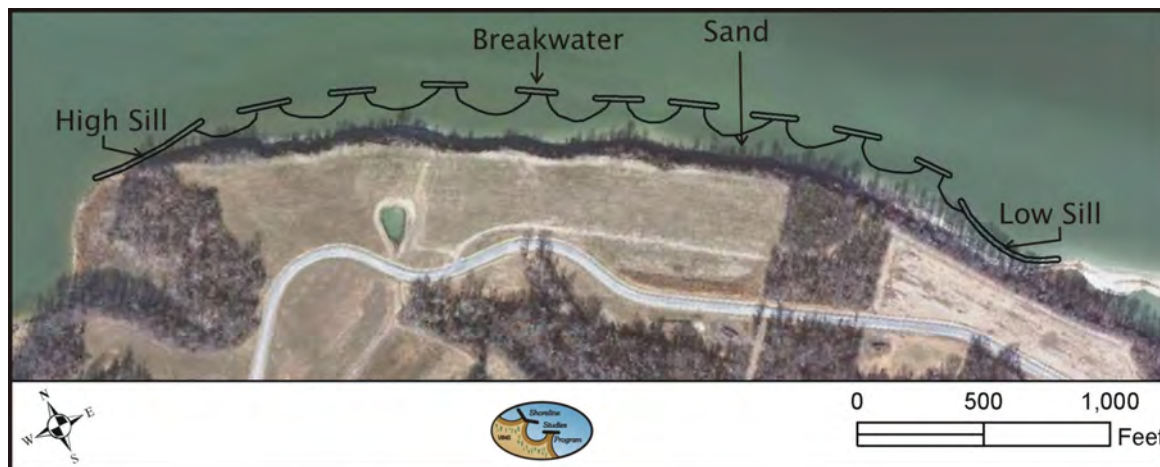
Figure 5-10. Recommended configuration of structures at Bettys Neck.

The suggested shore protection is a breakwater system along the main upland coast that transitions both up and downriver toward the bounding creeks (Figure 5-10). The typical cross-section for the bay and tombolo from the previous design presented can be used as a starting point (Appendix 3, Figure 3) for the design process. The 25 year storm event is the minimum design parameter. A breakwater length of

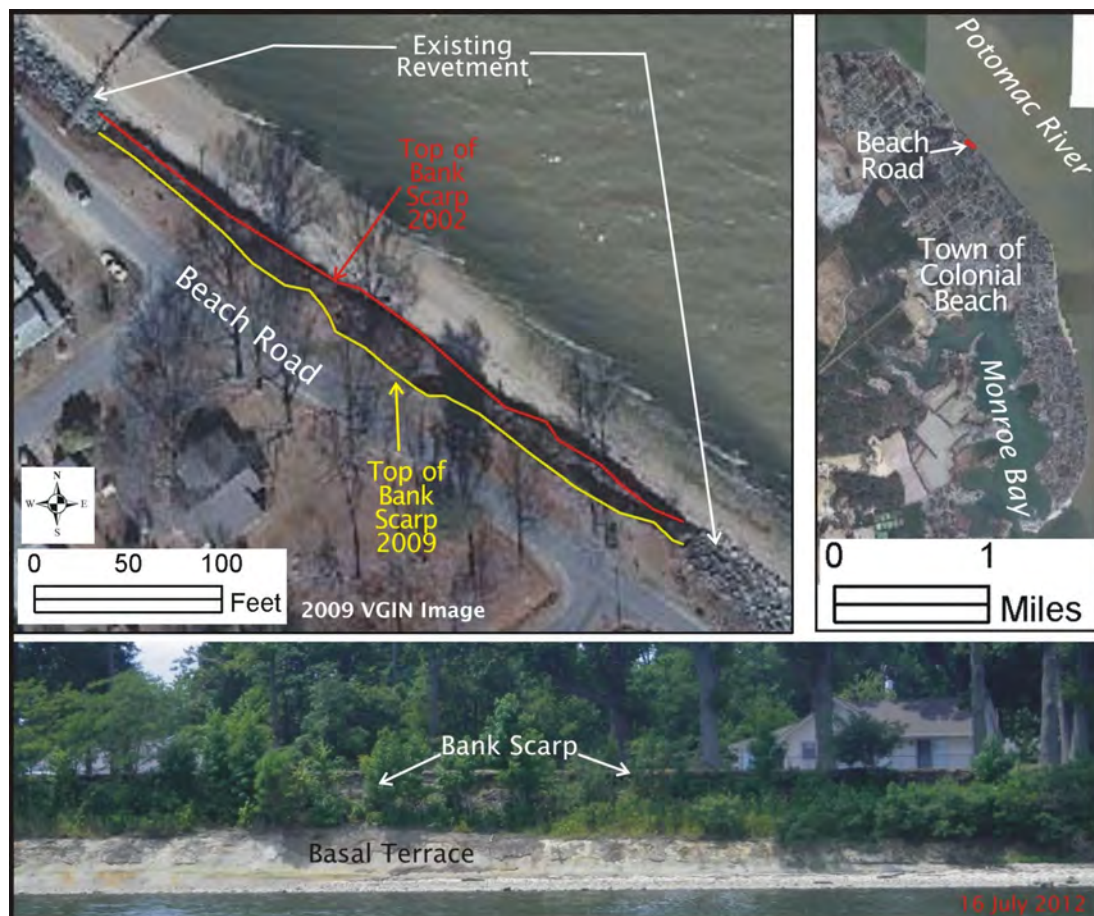
Figure 5-11. Eroding Beach Road shoreline between two existing revetments.

The revetment could be continued along this section; however, this site provides an excellent opportunity to install a Living Shoreline along the Potomac River. A high sill is recommended (Appendix 3, Figure 2) with the sand being placed up to the basal terrace with the bank graded above. The sill would have to extend beyond the adjacent revetments by 10 to 20 feet to insure sand fill integrity and bank protection.

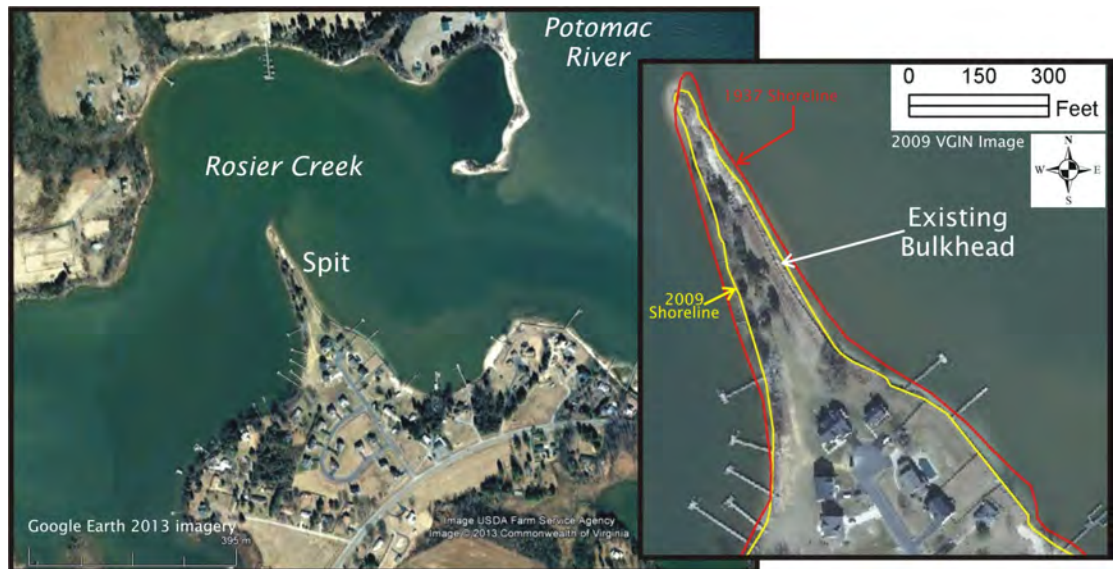
Figure 5-12. Location of spit near the mouth of Rosier Creek and the existing bulkhead. 1937 and 2009 shorelines from Milligan et al. (2012).

The narrow peninsula just inside the south side of the entrance to Rosier Creek is partially protected by a wood bulkhead along its river-facing coast (Figure 5-12) and is unprotected on the northern distal end and along the creek. However, a section of the structure has failed, and the upland bank behind has slumped down. (Figure 5-13). The failed section is an opportunity to create a Living Shoreline using the model-recommended sill. In fact, since the remaining wood bulkhead appears to need some toe stone, the sill could extend in front of the bulkhead and across the unprotected shore around the point and into Rosier Creek.

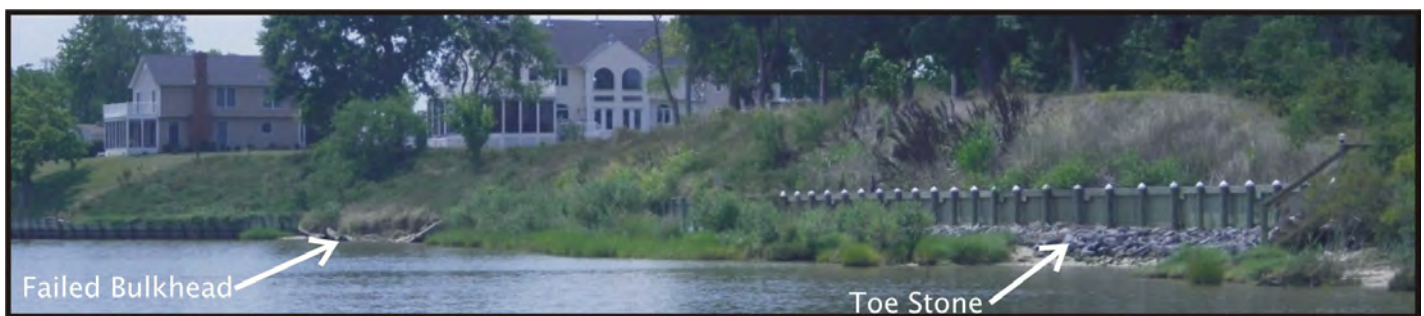
Figure 5-13. Photo showing the bulkhead along the spit in Rosier Creek with a failed section and toe stone.

Between 2009 and July 2012, an approximately 100 foot long section of bulkhead failed. In addition, toe rock can be seen in places. The preferred alternative to repair the failure is a high sill (Appendix 3, Figure 2) on the Potomac River side. To secure the remaining bulkhead's toe and address the erosion of the adjacent protected shore, a low sill (Appendix 3, Figure 1) should be considered with some bank grading which could be continued northward to the distal end of the spit and around into the creek.

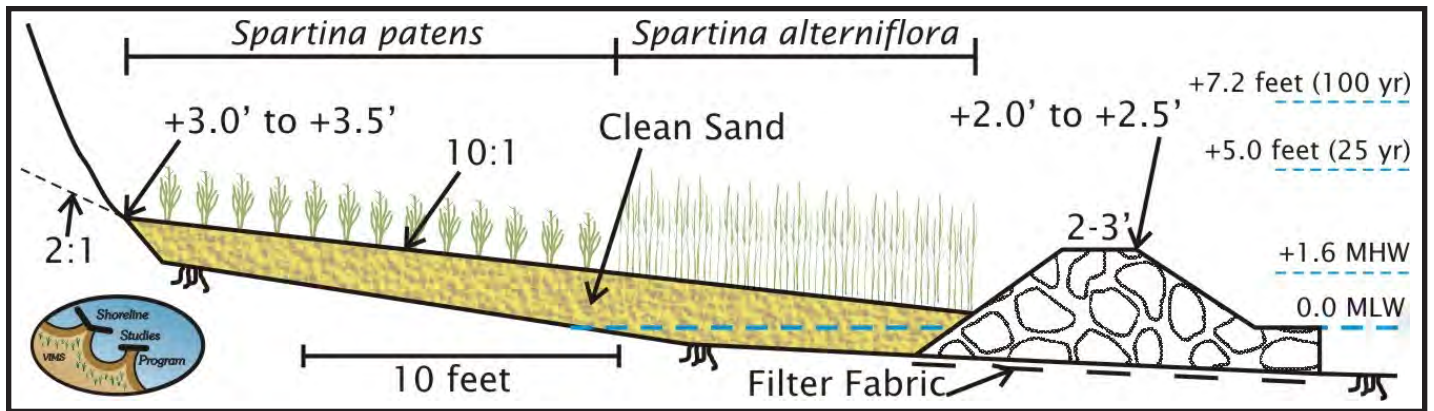
Figure 1. Typical cross-section for a low sill that is appropriate for low to medium energy shorelines of Westmoreland County. The project utilizes clean sand on an 10:1 (H:V) slope, and the bank can be graded to a (minimum) 2:1 slope, if appropriate.

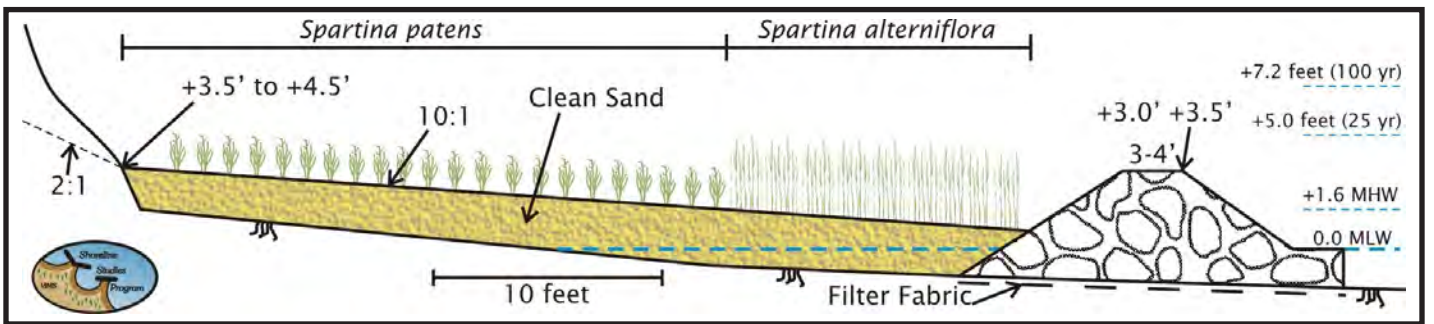
Figure 2. Typical cross-section for a high sill that is appropriate for the medium to high energy shorelines of Westmoreland County. The project utilizes clean sand on an 10:1 (H:V) slope, and the bank can be graded to a (minimum) 2:1 slope, if appropriate.

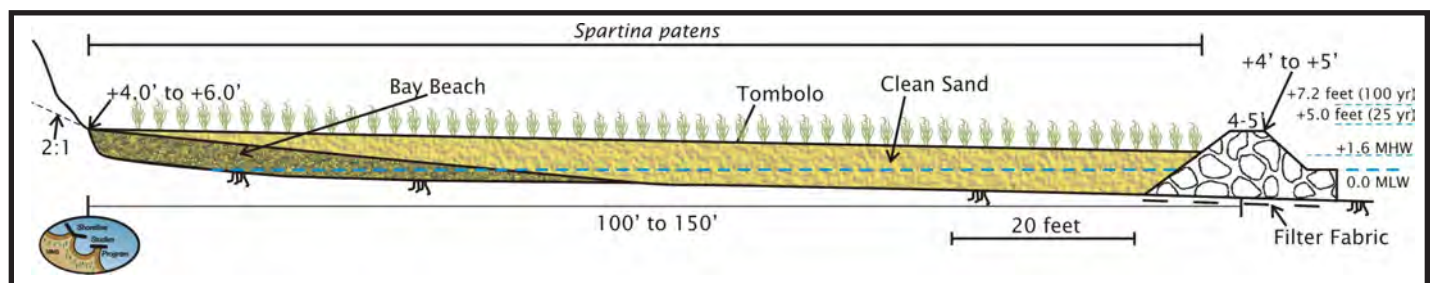
Figure 3. Typical cross-section for a breakwater system that is appropriate for the medium to high energy shorelines of Westmoreland County. Shown is the cross-section for the tombolo and rock structure. In addition, the typical cross-section for the bay beach between the structures is superimposed in a slightly different color. Note: the beach material is the same for the two cross-sections.
